INDOOR AIR QUALITY ASSESSMENT

**Department of Mental Health (DMH) Lindemann Building
Central Office Mezzanine
25 Staniford Street, Boston**

Prepared by:
Massachusetts Department of Public Health
Bureau of Environmental Health
Indoor Air Quality Program
July 2019

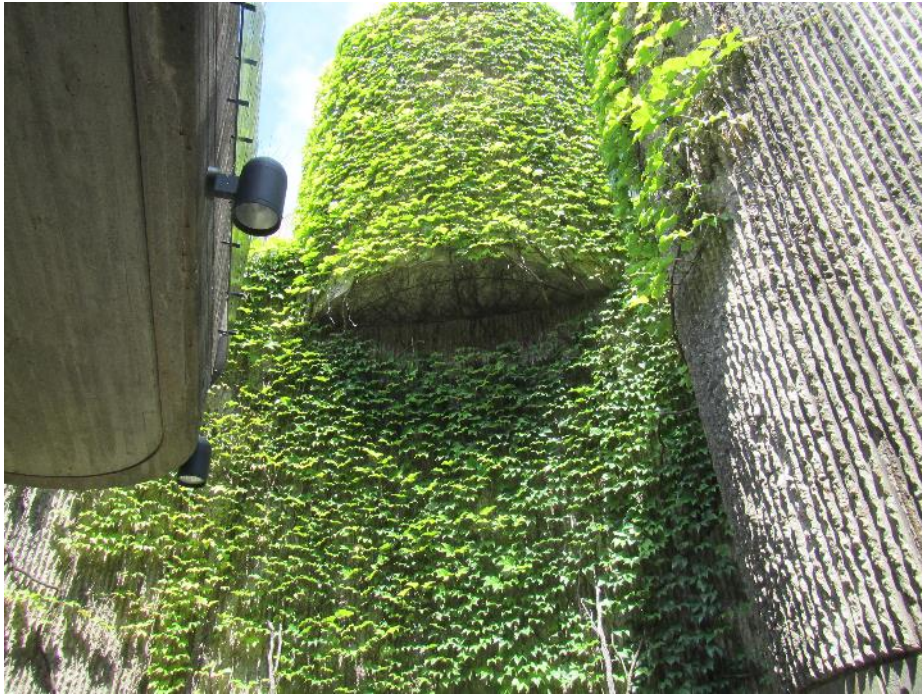
Picture 1

No direct source of the odor was found during either visit, although several potential sources were eliminated. The odor was not associated with carpeting, furniture or other items in the employee entrance. While they were not a source of the odor during the visit, large amounts of ivy, mulch and other plants were found against the building (Picture 1). This can lead to odors and degrade the exterior surfaces of the building which will make water intrusion more likely over time. Items in the elevator lobby and hallway, including carpeting, were also examined and none appeared to be the source of the odor.

Ivy covering walls outside employee entrance

5. Trim back vines and plants from the building near the entranceway and remove mulch and accumulations of plant detritus.
6. Operate supply and exhaust ventilation continuously in all areas during occupied periods. Ensure all HVAC equipment is cleaned/maintained in accordance with manufacturer's instructions including filter changes.
7. Clean carpeting annually or more frequently per the recommendations of the Institute of Inspection, Cleaning and Restoration Certification (IICRC).
8. Clean dusty vents periodically to prevent reaerosolization or moistening.
9. Refer to resource manual and other related IAQ documents located on the MDPH's website for further building-wide evaluations and advice on maintaining public buildings. These documents are available at: <http://mass.gov/dph/iaq>.

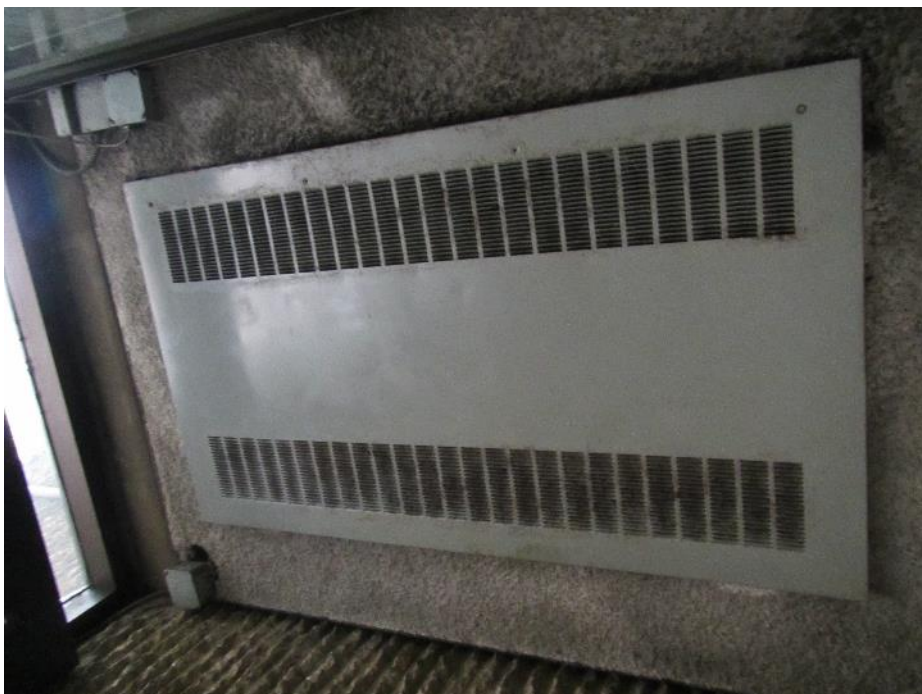
Picture 2

Some vents were found to be dusty (Picture 2). Dust can be reaerosolized and cause irritation. It can also become a medium for mold growth if moistened due to leaks or high humidity.

Dusty vent in employee entrance area
